NEW MEXICO ENVIRONMENT DEPARTMENT

**Re: Desert Mountain Transportation, Inc. dba Desert Mountain Corporation; Kirtland, New Mexico;
Unpermitted MSGP; SIC 4213/NAICS 484121; Compliance Evaluation Inspection; NPDES
Tracking No. NMU001932; April 6, 2017**

NPDES Compliance Inspection Report

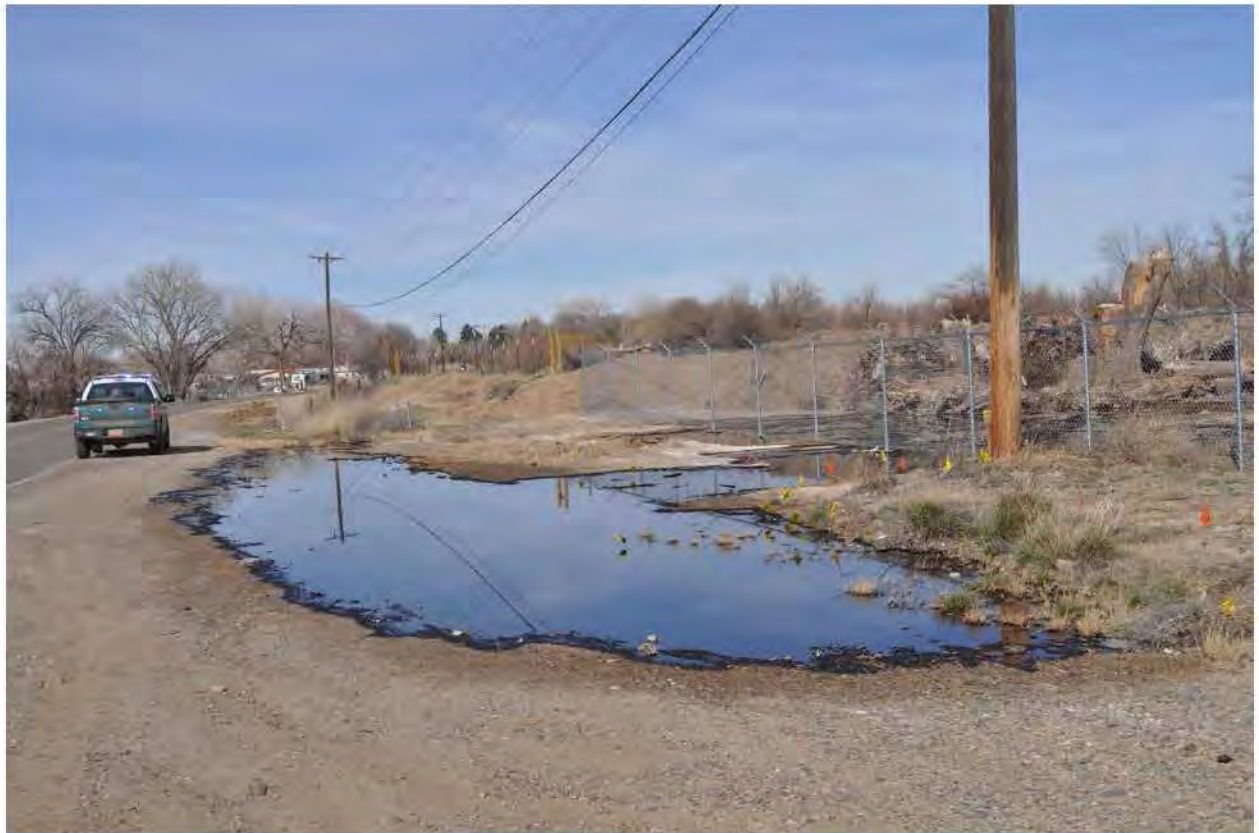
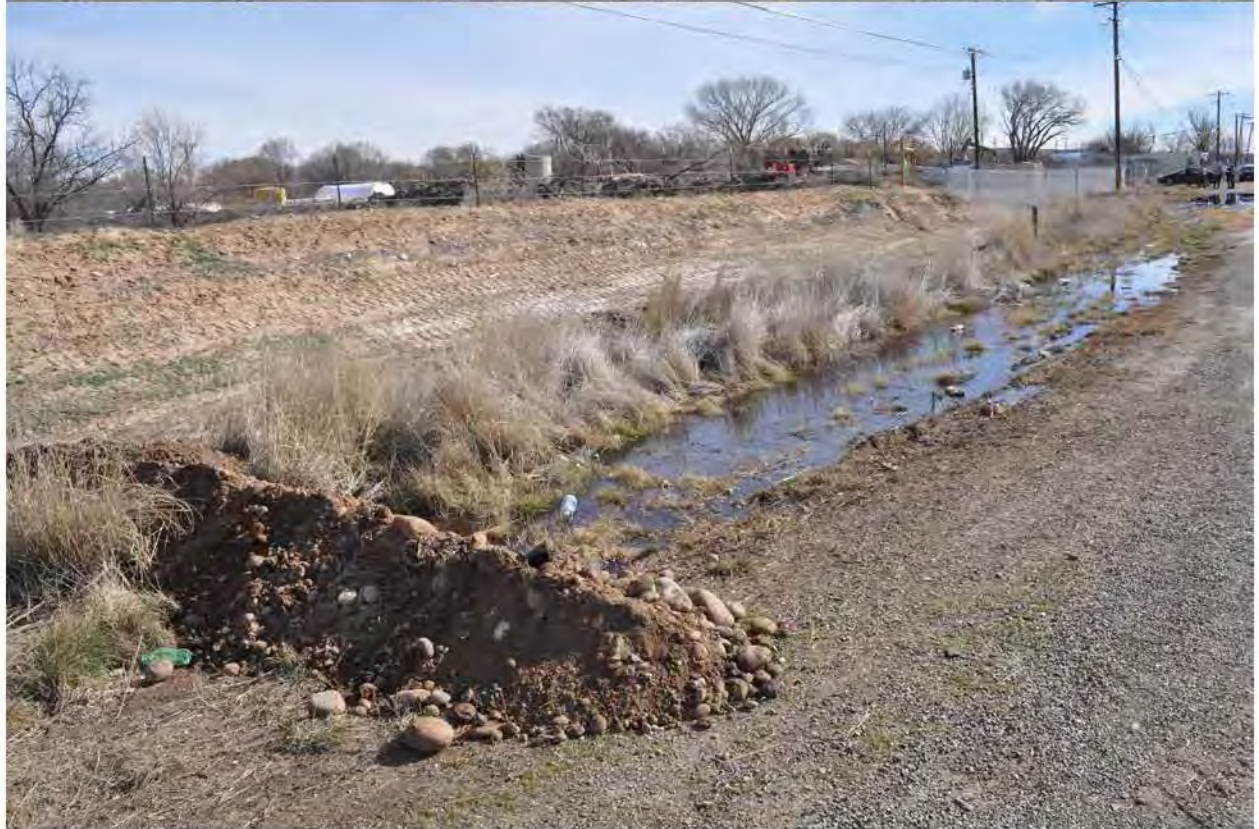
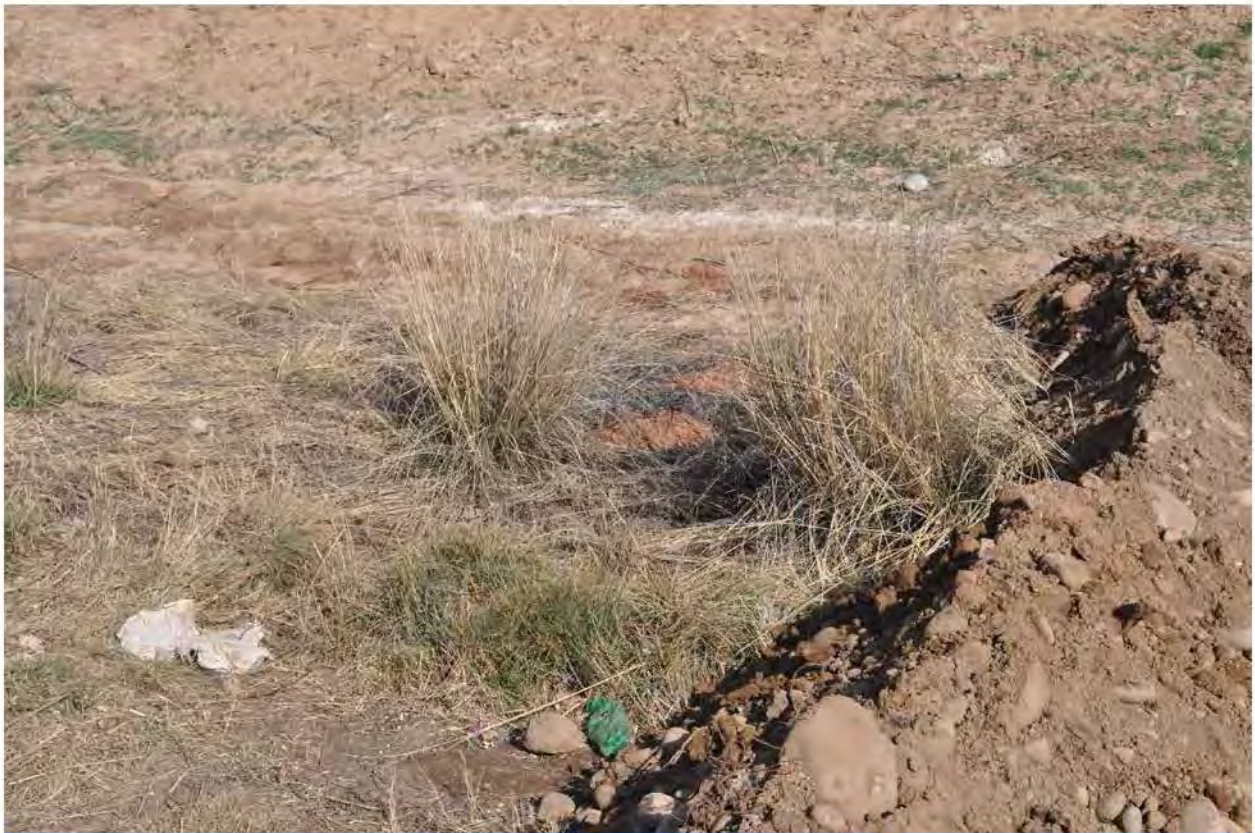
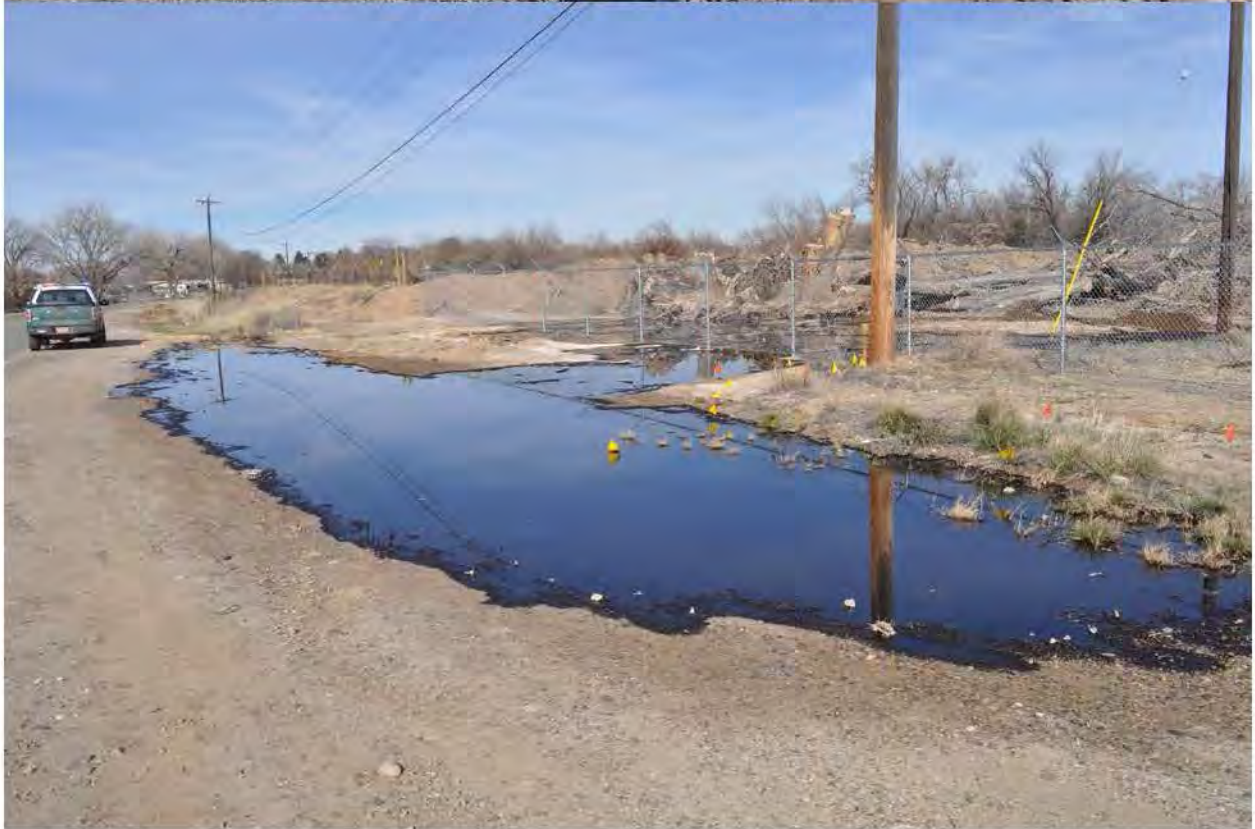
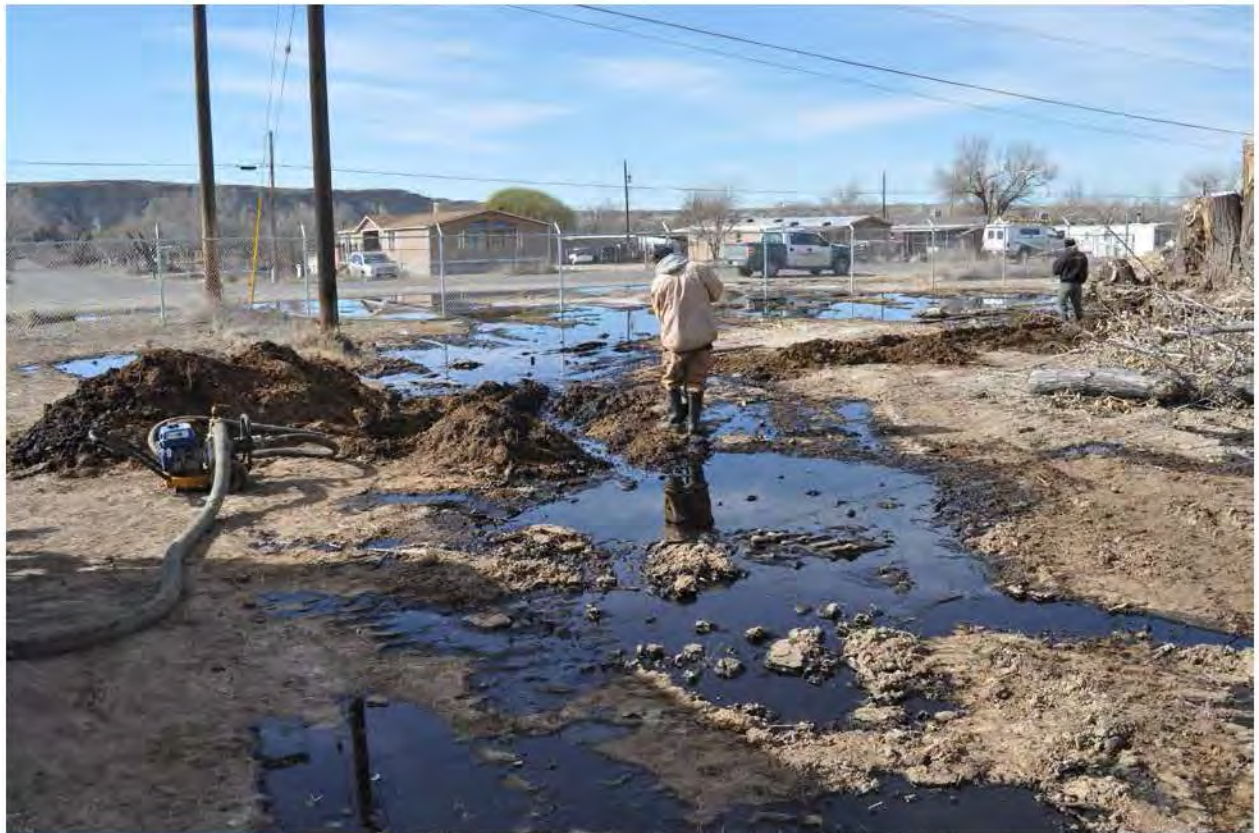
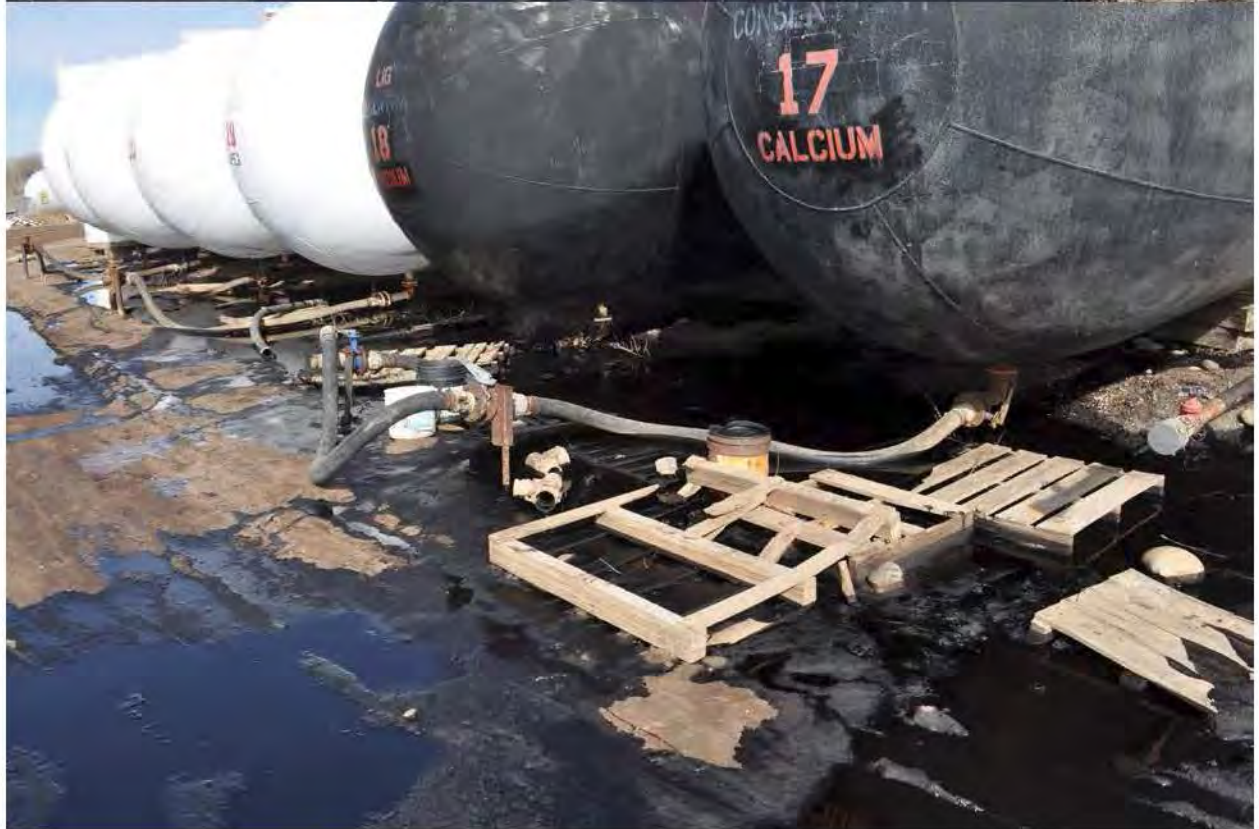
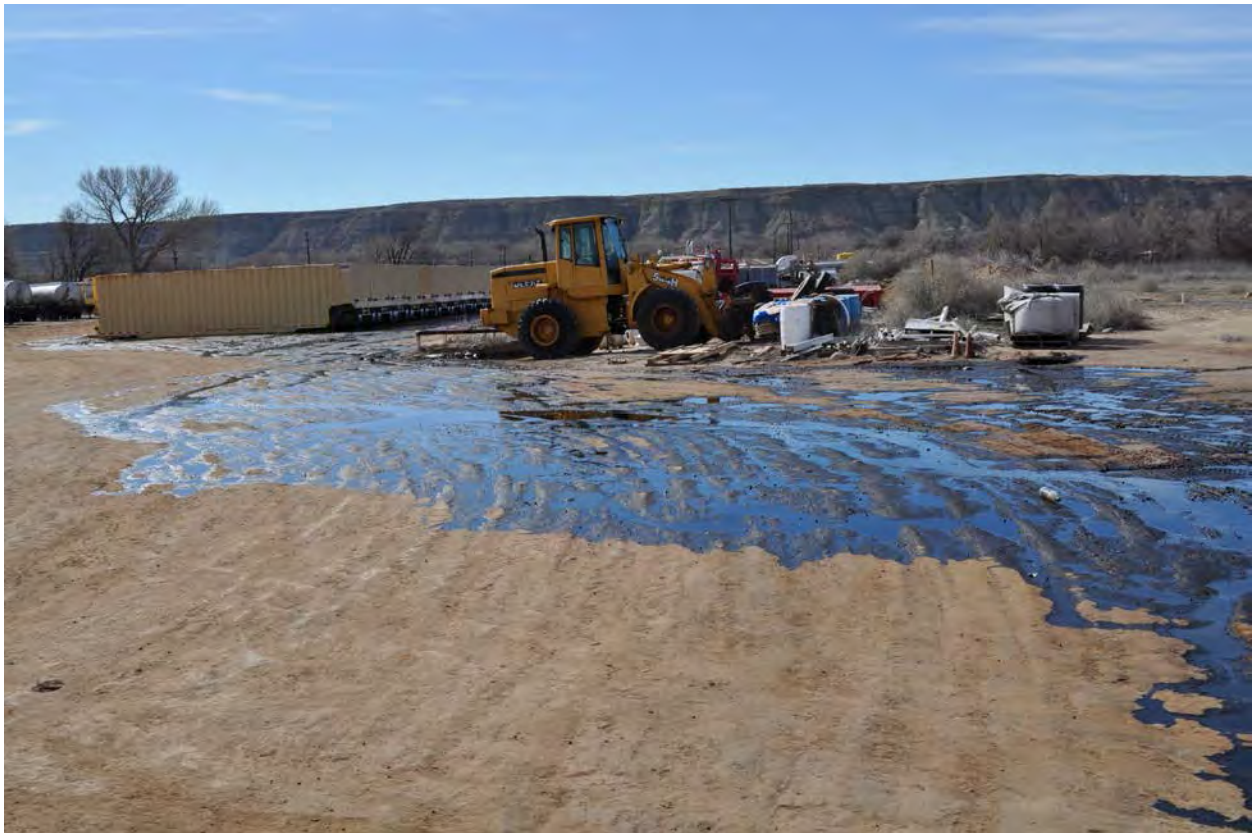
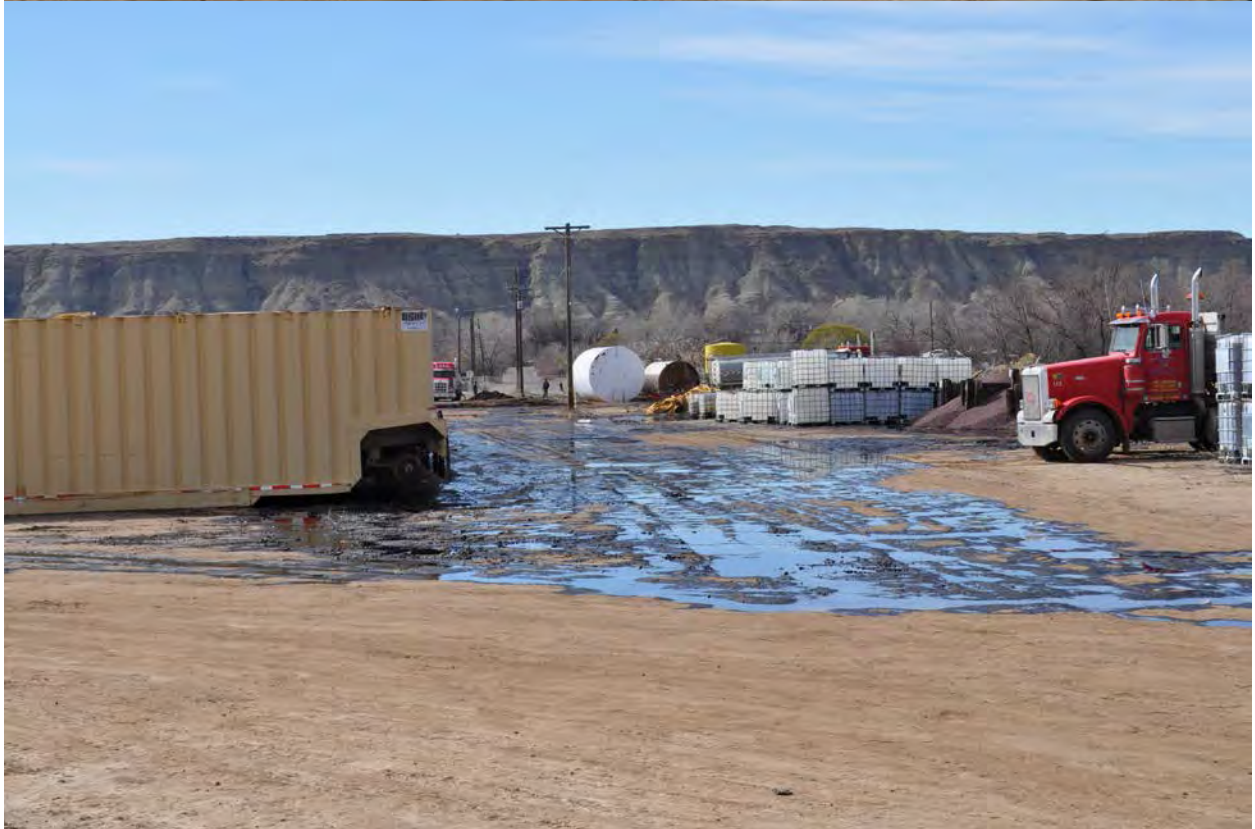
On the night of March 9-10, 2017, Justin Patterson (company driver) was in the yard with his truck and discovered a spill on the ground that appeared to have some from the sodium lig tank. He called dispatcher Troy West; who came down to the yard to verify and see what could be done. At this point, no more liquid was being released from the tank. Justin had already closed and capped all other tanks, to be sure that nothing else would leak.

On the morning of March 10, in the daylight, we could better see the amount that had drained from the tank, and also ascertain that there had be a failure of one of the valves of the tank itself. The cap had not been replaced, which might have contained the liquid if it had been in place.

Upon going through the causal factors (cap not on, secondary valve left open, the one valve that was closed failed) new work procedures were developed for closing and capping the valves coming off of the tanks. Also, there are new work procedures for anyone connecting to, or filling the tanks. Two people, usually the driver and a yard worker, need to be present to verify steps have been taken to open/close/disconnect, and verify the tanks are double-valve closed, and capped after using.

It has been decided by the owners, that there will be two capture ponds dug and lined, between our holding tanks and our south property line, in the event that we have any spills in the future. We now also have added a 2 ½' to 3' dirt berm containing any runoff from our property until the ponds are completed. There is now a pit dug under the tank valves, which was not there prior to the spill.
